PREMIUM HOME INSPECTIONS

RESIDENTIAL REPORT

Your Name
JANUARY 4, 2025

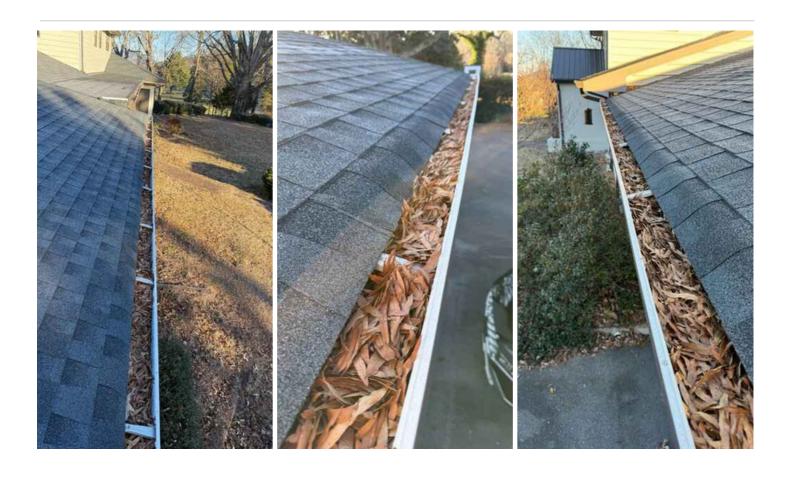
Debris has accumulated in the gutters. Recommend cleaning to facilitate water ow. Here is a DIY resource for cleaning your gutters.

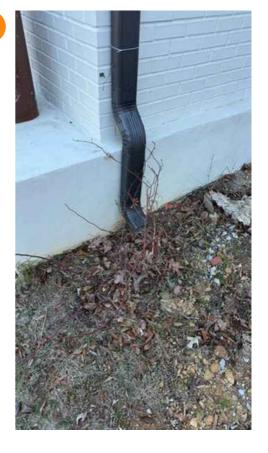
2.2.2 Roof Drainage Syste Recommendation DOWNSPOUTS DRAIN NEAR HOUSE

One or more downspouts drain too close to the home's foundation. This can result in excessive moisture in the soil at the foundation, which can lead to foundation/structural movement. Recommend a quali ed contractor adjust downspout extensions to drain at least 6 feet from the foundation.

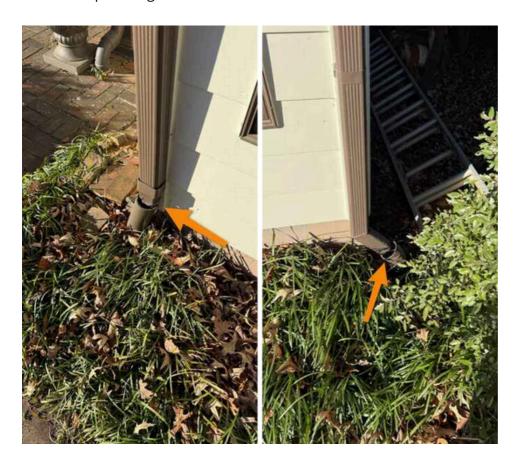
2.2.3 Roof Drainage Systems **GUTTER DAMAGED**

Gutters were damaged. This can result in excessive moisture in the soil at the foundation, which can lead to foundation/structural movement. Recommend a quali ed contractor evaluate and repair. Recommendation

Contact a quali ed gutter contractor

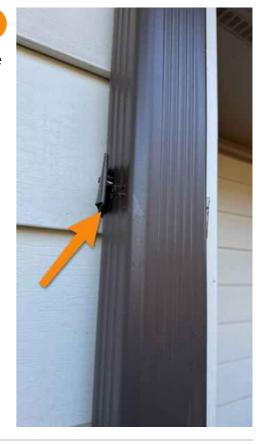
2.2.4 Roof Drainage Syste Recommendation **GUTTER DOWNSPOUT LOOSE**

The gutter downspout(s) are loose. They need to be reattached to the home to prevent future issues with the gutter system.

Contact a quali ed professional.

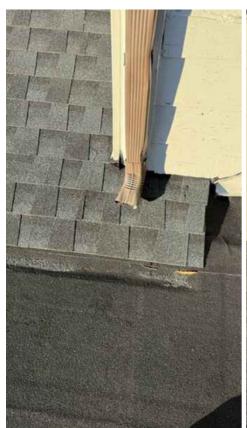
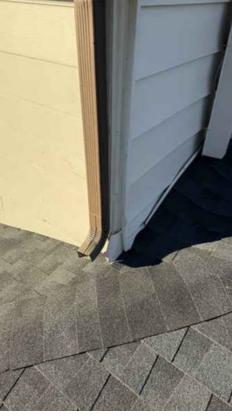
Discharging gutter on to roof will cause premature wear on shingles and can cause damage. Recommendation

Gutter Improperly Discharging onto Roof

Contact a quali ed professional.

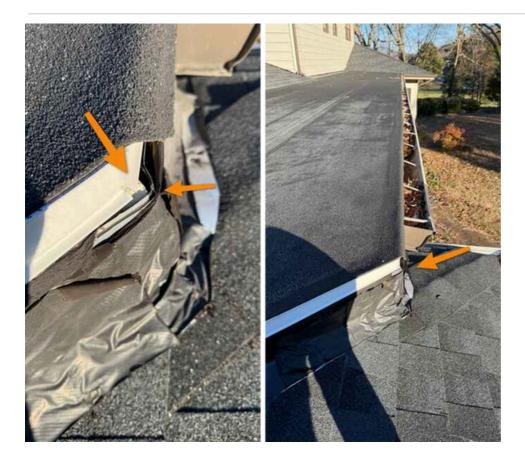
LOOSE/SEPARATED

Flashings observed to be loose or separated, which can lead to water intrusion and/or mold. Recommend a quali ed roo ng contractor repair.

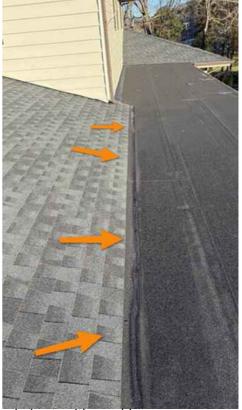
missing trasition ashing.

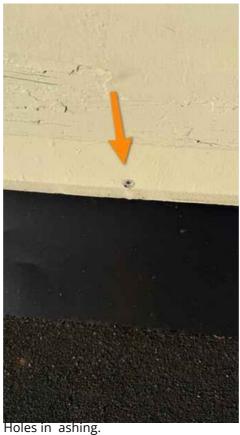
Holes in ashing.

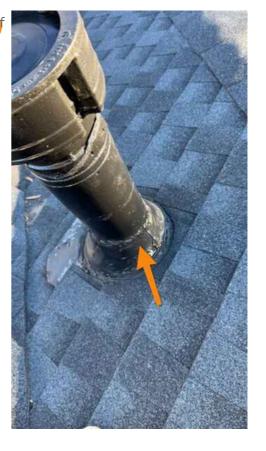
STORM COLLAR MISSING

Contact a quali ed professional.

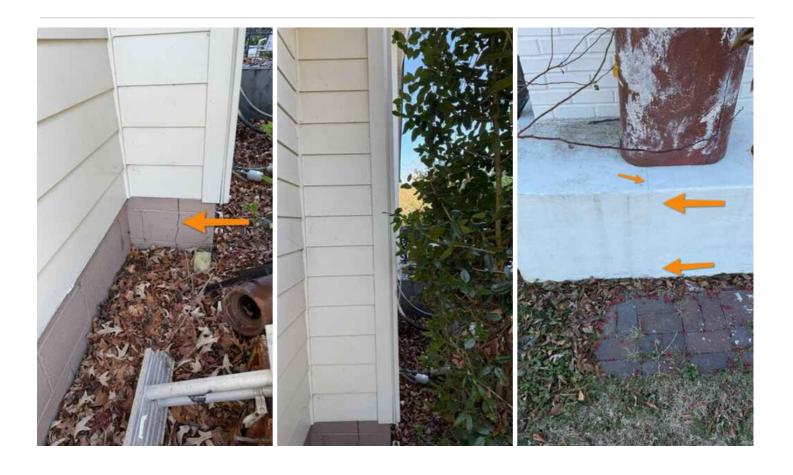
CRACKING - MAJOR

Moderate to major cracking was observed at one or more points on the exterior. This can be the result of poor original compaction of soil at the time of construction or excess moisture in the underlying soil. Recommend consulting with a structural engineer and/or soil expert.

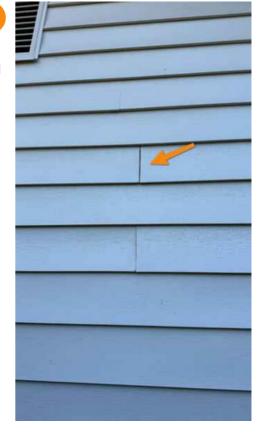
GAPPING

Vinyl siding has gaps, which can lead to water intrusion. Recommend having a quali ed professional to evaluate and correct.

Contact a quali ed professional.

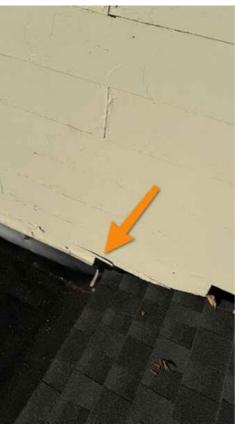
3.2.3 Siding, Flashing & Trim **SPLITTING**

Premium Home Inspections Page 17 of 75 Siding shingles was splitting in one or more areas, which can lead to moisture intrusion and/or mold. Recommend monitoring for excessive splitting, in which case a quali ed siding contractor should evaluate and repair/replace.

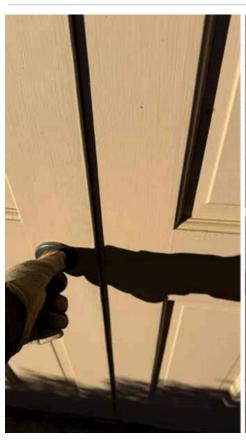
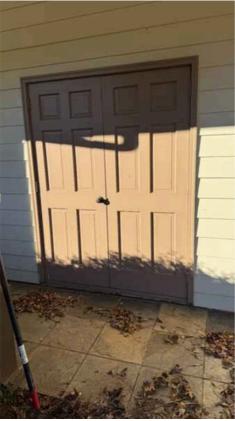
DOOR DOES NOT CLOSE OR LATCH

Door does not close or latch properly. Recommend quali ed handyman adjust strike plate and/or lock. Here is a DIY troubleshooting article on xing door issues.

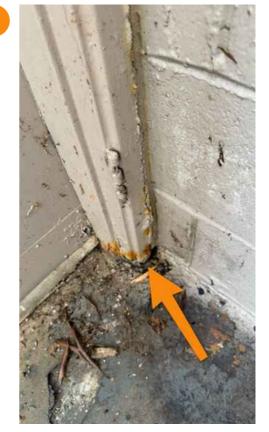
BASEMENT DOOR

HARDWARE DAMAGED

One or more pieces of door hardware are damaged. Recommend repair or replace.

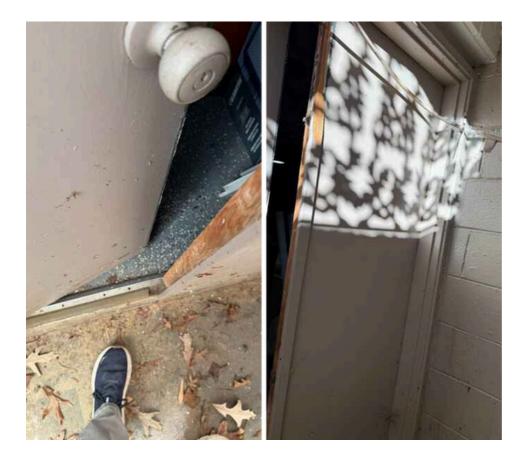
DOOR RUBS

Door needs to be adjusted to operate smoothly to prevent unnecessary wear.

Contact a quali ed professional.

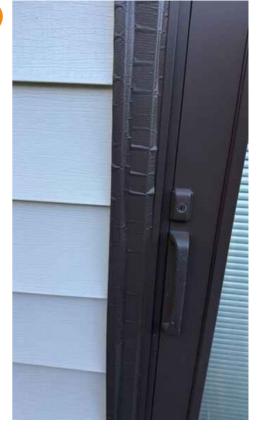
DOOR TRIM DEFECT

Door is trimmed and sealed incorrectly. Which can allow water intrusion. Recommend a quali ed professional to inspect and correct.

Contact a quali ed professional.

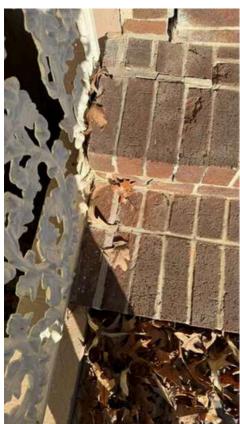
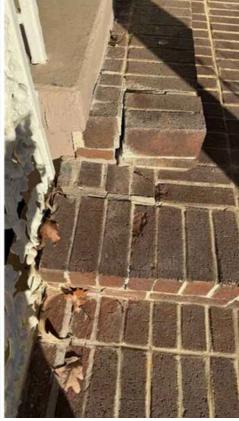
REAR OF HOME BY BASEMENT STAIRS

STAIRS - DETERIORATED

One or more sections of the exterior stairs are deteriorated. Recommend quali ed concrete contractor evaluate & repair.

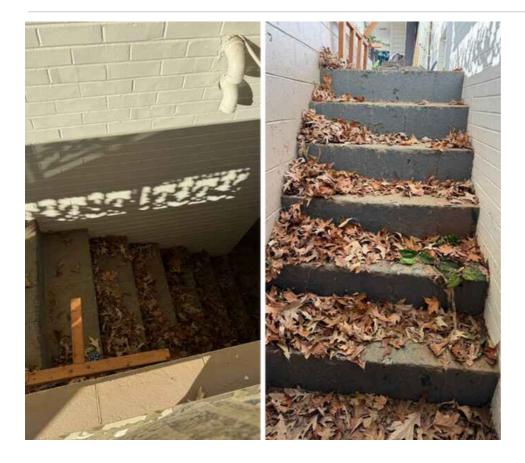
Stairs were covered with debris at the time of inspection. Recommend removing debris to avoid tripping and fall hazards.

Contact a quali ed professional.

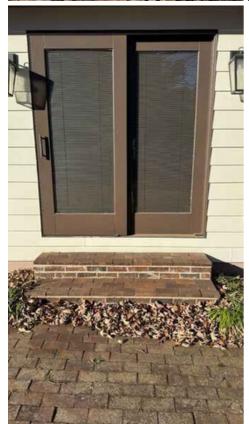
MISSING HANDRAIL

Handrails are recommended for three or more steps.

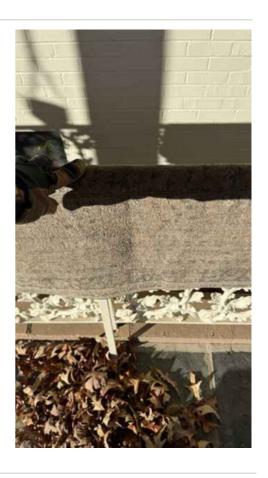
RAILING LOOSE

Railing was loose at time of the inspection. Recommend a quali ed professional inspect and correct loose railing to prevent injury.

Contact a quali ed professional.

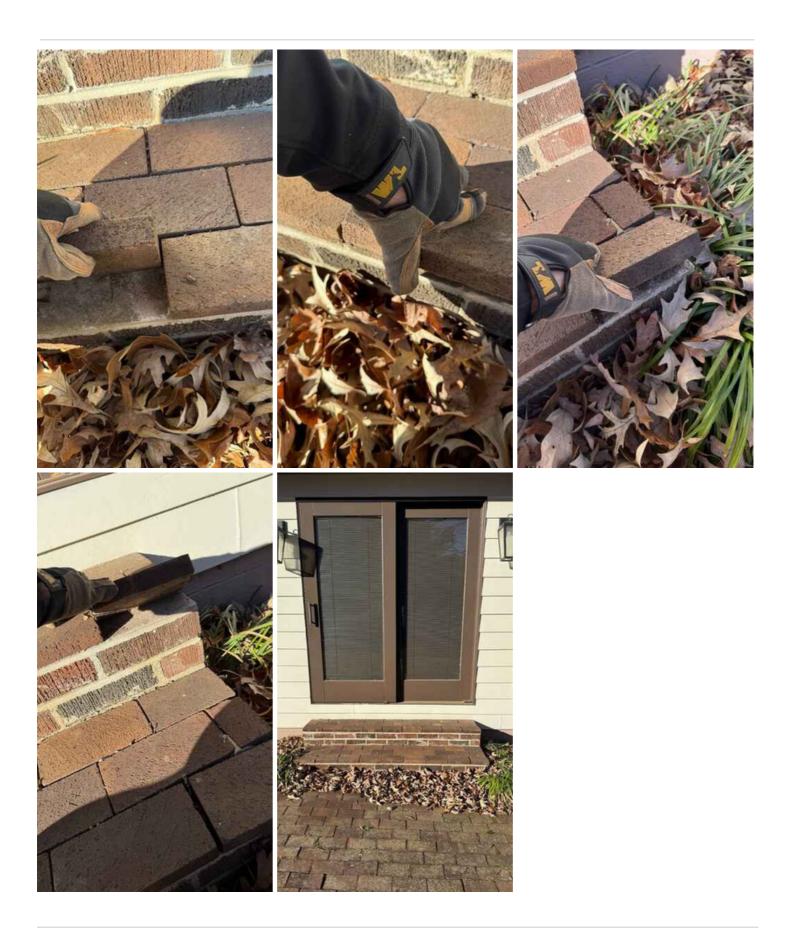
STEPS LOOSE

One or more steps had loose tread material. Recommend having a quali ed professional inspect and correct issue.

Contact a quali ed professional.

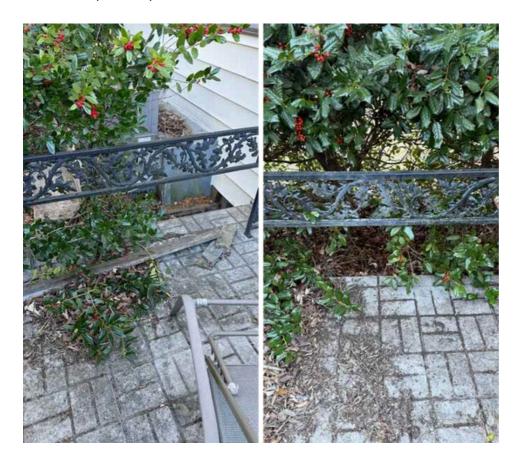
3.4.6 Decks, Balconies, Porches & Steps GUARD OPENING WAS TOO LARGE (4")

I observed improper spacing between intermediate balusters, spindles and rails at a required guard. This is a safety hazard, especially for small children.

Correction and further evaluation is recommended.

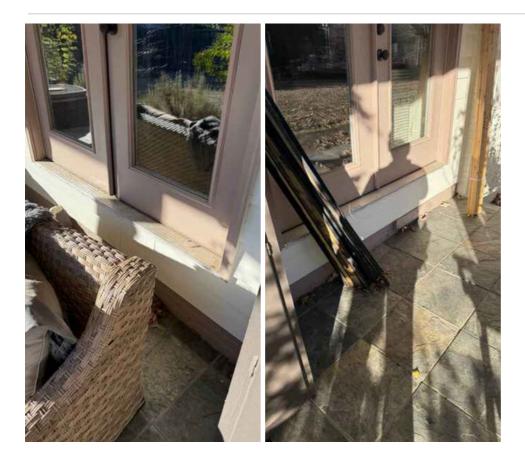
STEPS MISSING

Missing Steps at time of inspection. Recommend having a quali ed professional inspect and install steps at door.

Contact a quali ed professional.

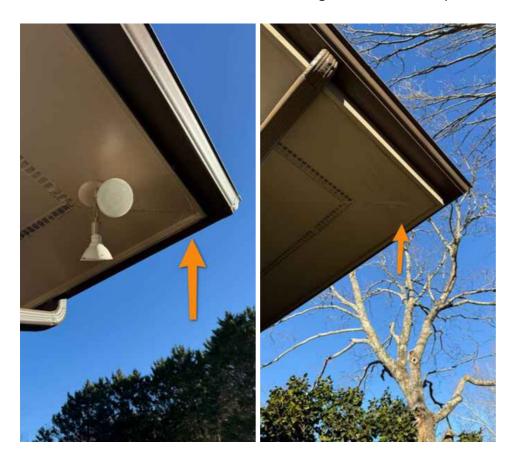
EAVES - DAMAGED

One or more sections of the eaves are damaged. Recommend quali ed roofer evaluate & repair.

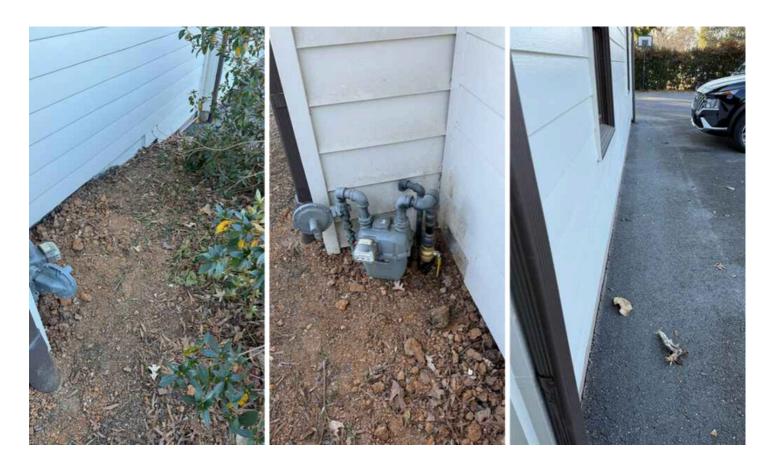
Grading is sloping towards the home in some areas. This could lead to water intrusion and foundation issues. Recommend quali ed landscaper or foundation contractor regrade so water ows away from

Recommend monitoring.

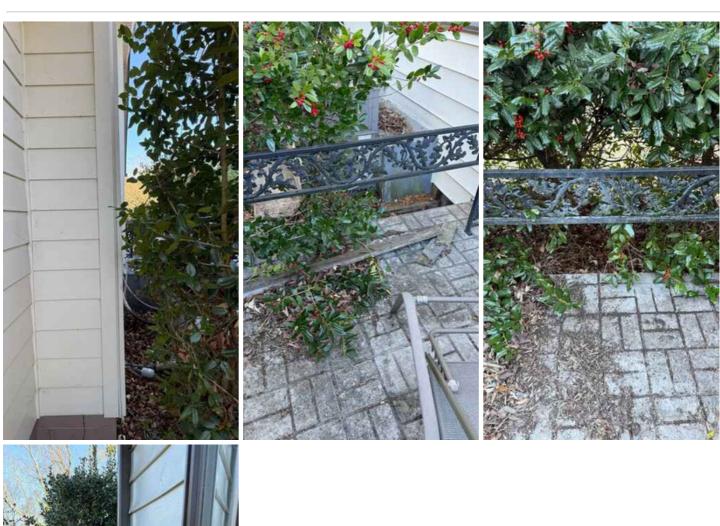
Recommend trimming vegetation back at least one foot away from any portion of the house or handrails. This prevents water and pest intrusion and excessive wear of siding paint and roo ng materials. Recommendation

Contact a quali ed professional.

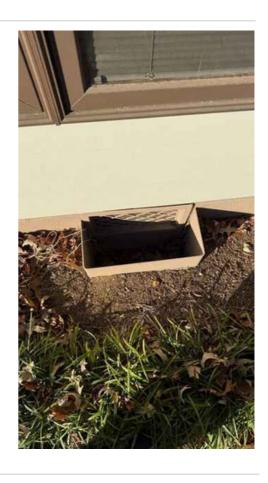
WINDOW WELL COVER MISSING

Recommend window well cover to be installed to prevent fall hazard.

Contact a quali ed professional.

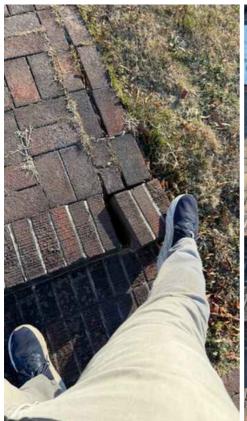
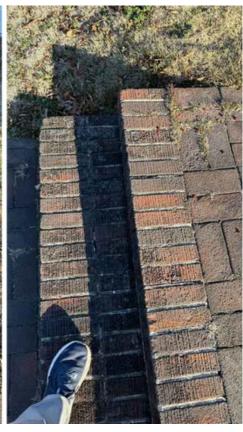
WALKWAY CRACKING - MAJOR

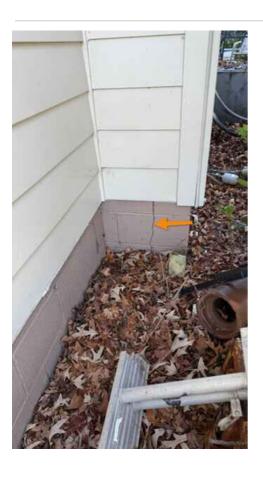
FOUNDATION CRACKS - MINOR

Minor cracking was noted at the foundation. This is common as concrete ages and shrinkage surface cracks are normal. Recommend monitoring for more serious shifting/displacement.

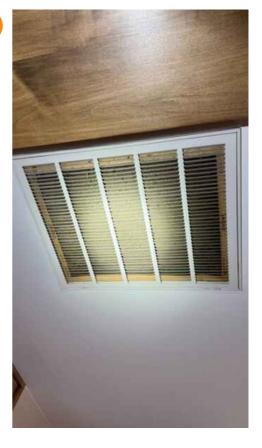
FILTER DIRTY

The furnace lter is dirty and needs to be replaced every 6 months.

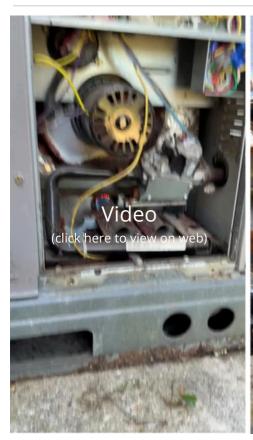
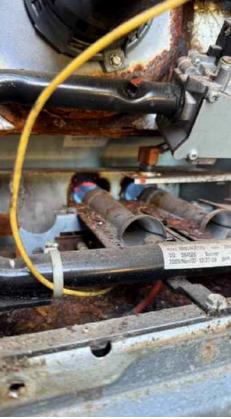
NEEDS SERVICING/CLEANING

Furnace should be cleaned and serviced annually. Recommend a quali ed HVAC contractor clean, service and certify furnace.

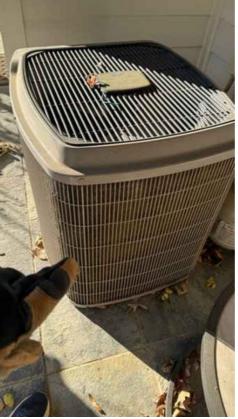
Air ow to the air conditioner condenser was restricted. This may result in ine cient operation. Recommend cleaning dirt and/or debris from unit.

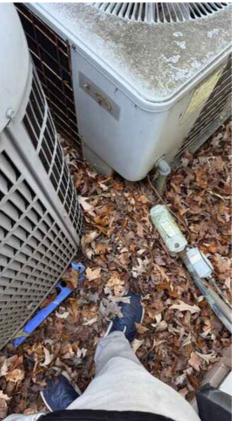
INSULATION MISSING OR DAMAGED

Missing or damaged insulation on refrigerant line can cause energy loss and condensation.

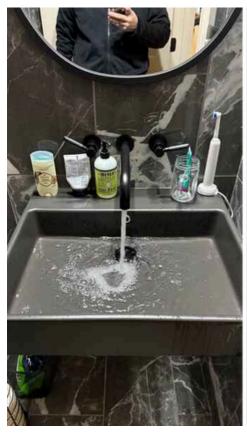
LEAKING PIPE

A drain, waste and/or vent pipe showed signs of a leak. Recommend a quali ed plumber evaluate and repair.

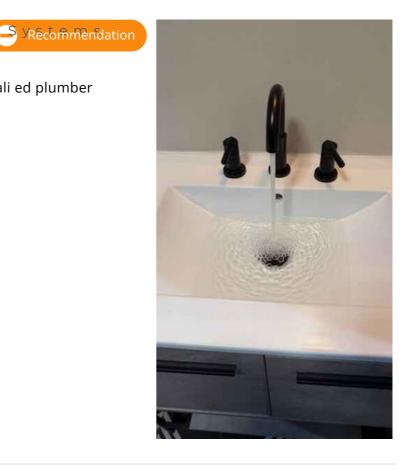
UPSTAIRS MAIN BATHROOM

Sink had slow/poor drainage. Recommend a quali ed plumber repair.

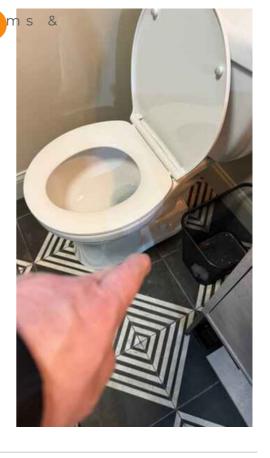
TOILET LOOSE

Toilet loose mount. Recommend a quali ed professional inspecting and correcting to prevent damage and leaks.

Contact a quali ed professional.

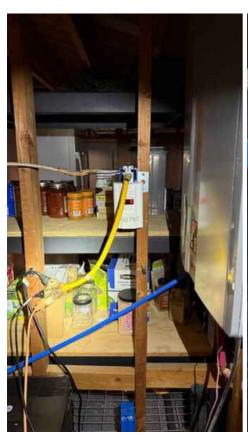
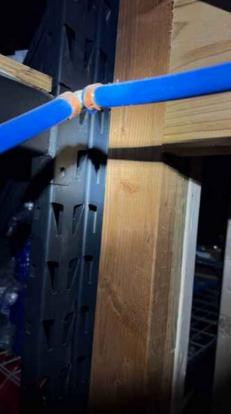
WATER STAINS - LEAKAGE

Water stains were observed beneath water heater, indicating a past or present leak. Recommend further evaluation and repair by a quali ed plumber.

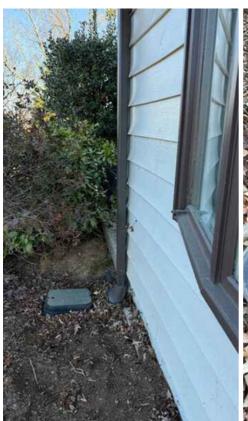
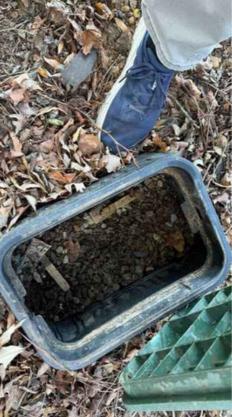
GAS ODOR - SEVERE

Excessive gas odor was present around meter. Recommend consulting with your local utility company or quali ed gas company to evaluate for potential leaks.

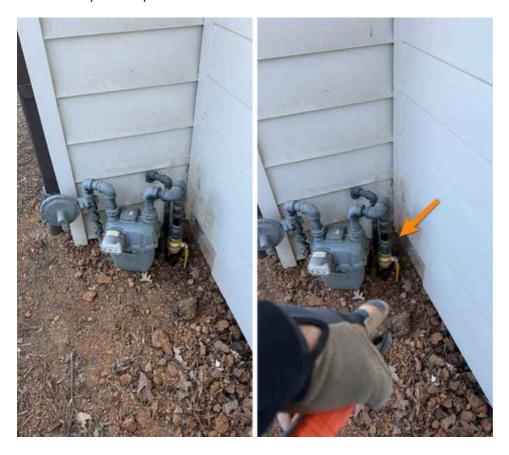
Recommend painting gas line joints to prevent rust. Rust can cause leaks in gas lines.

Contact a quali ed professional.

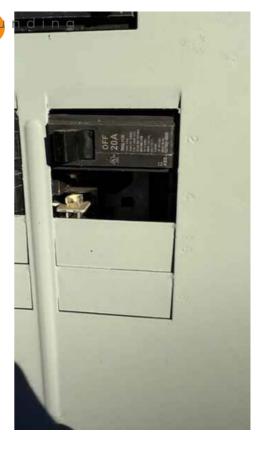
KNOCKOUTS MISSING

"Knockouts" are missing on the electric panel. This poses a safety hazard and it is recommended that the opening in the panel caused by the missing knockout(s) be properly sealed by a licensed electrician.

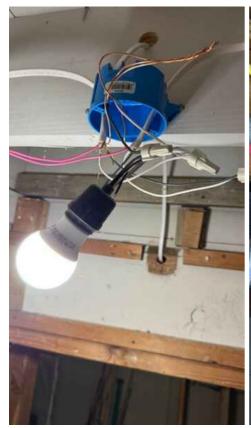
COVER PLATES MISSING

One or more receptacles are missing a cover plate. This causes short and shock risk. Recommend installation of plates.

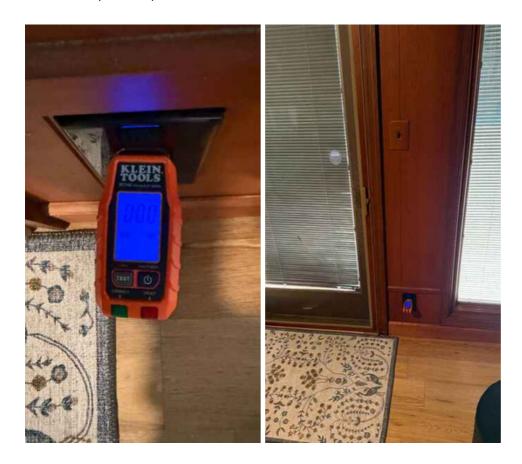
Receptacle not operational at time of inspection. Recommend having a quali ed electirician inspect and correct.

Contact a quali ed professional.

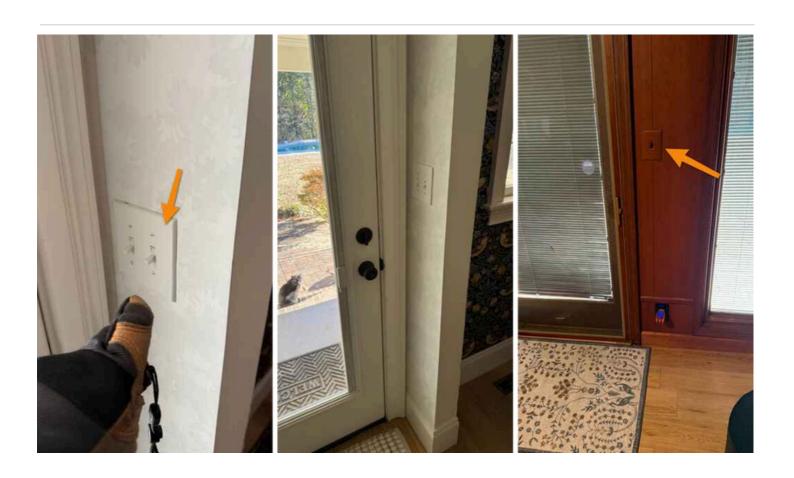
Switch purpose unknown. I recommend asking the current occupant about what switch controls. Recommendation

Contact a quali ed professional.

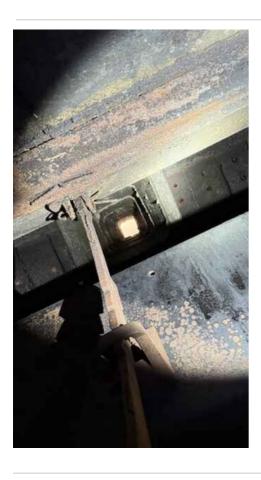
Recommend having a Chimney sweep clean and inspect chimney. Recommendation

Contact a quali ed professional.

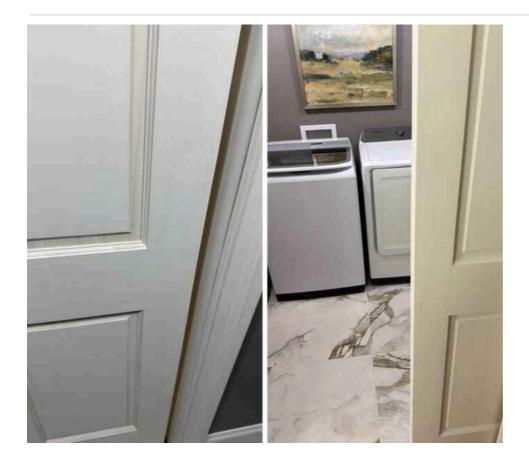
DOOR HANDLE MISSING

There was no handle to operate sliding pocket door at the time of inspection. Recommend having a quali ed professional inspect and install handle.

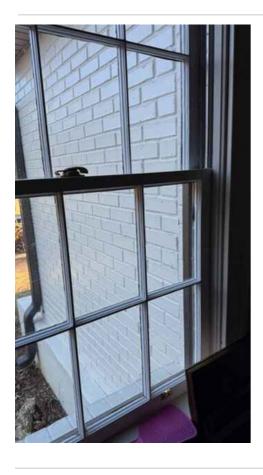
MISSING SCREEN

Multiple Windows missing screen. Recommend replacement.

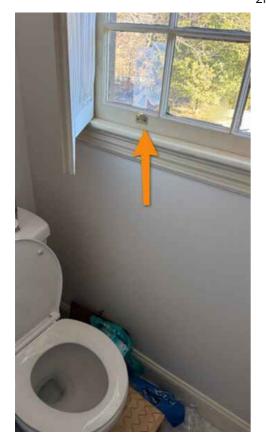
BROKEN PANE

One or more windows had broken panes. Recommend having a quali ed professional inspect and replace broken panes

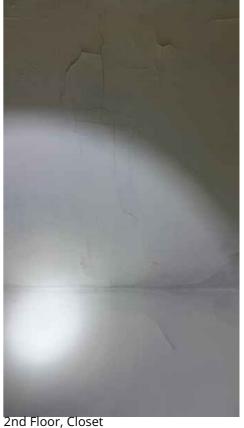
PAINT CRACKING

Here is a DIY article on treating cracking paint.

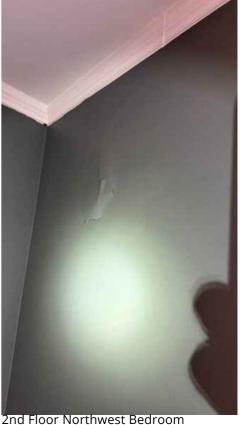
POOR PATCHING

Sub-standard drywall patching observed at time of inspection. Recommend re-patching.

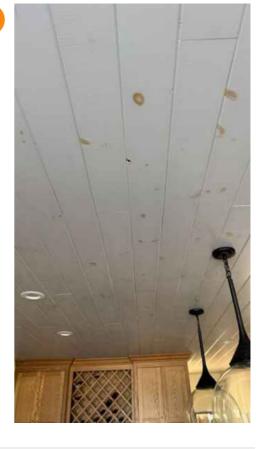
MINOR DAMAGE

Minor damage or deterioration to the ceiling was visible at the time of the inspection.

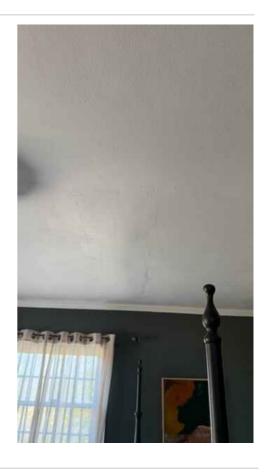
POOR PATCHING

Premium Home Inspections Page 65 of 75 Sub-standard drywall patching observed at time of inspection. Recommend re-patching.

Contact a quali ed professional.

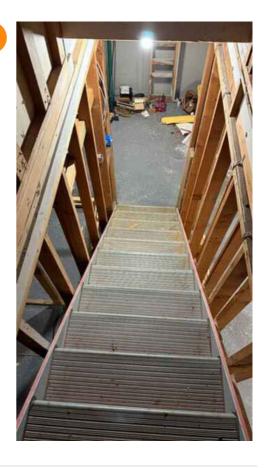
NO HANDRAIL

Staircase had no handrails. This is a safety hazard. Recommend a quali ed handyman install a handrail.

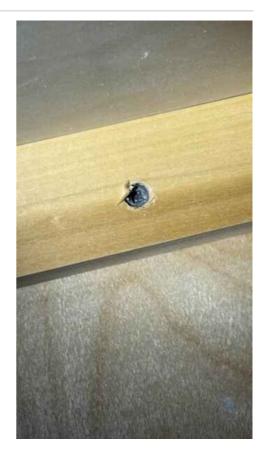
11.7.1 Countertops & Cabine Recommendation CABINET INSTALLATION IMPROPER SC RE WS

Premium Home Inspections Page 66 of 75 Improper screws used to install cabinets. Recommend quali ed professional changing them to proper screws. Screws should be panhead or have a washer to prevent pull through.

Contact a quali ed professional.

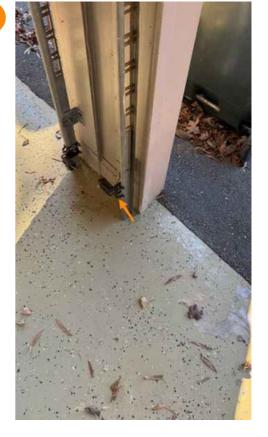
Recommend sensor eyes to be installed no higher than 6 inches above oor.

Contact a quali ed professional.
